Composite Failure Analysis Handbook Update #1

Boeing Defense & Space Group

April 1995

Final Report for the Period Aug 90 - Apr 95

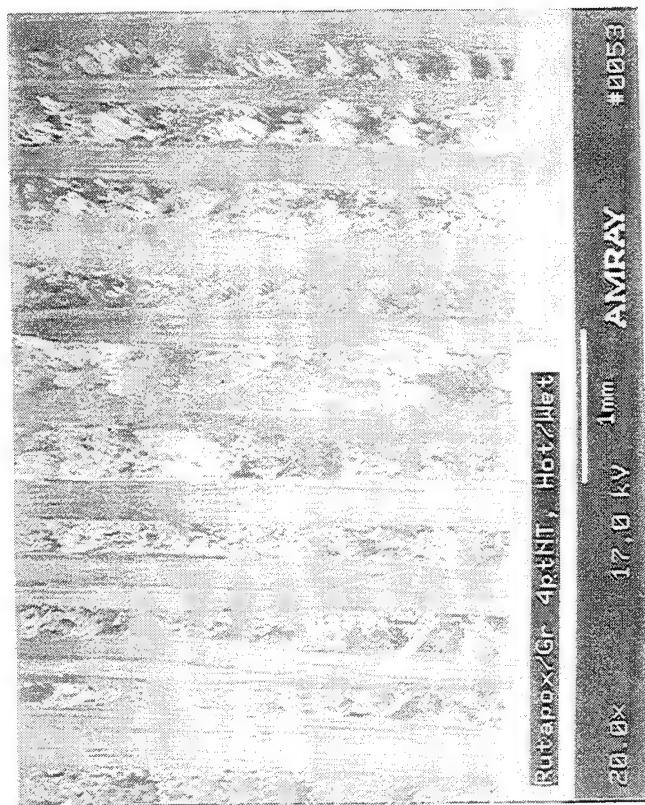
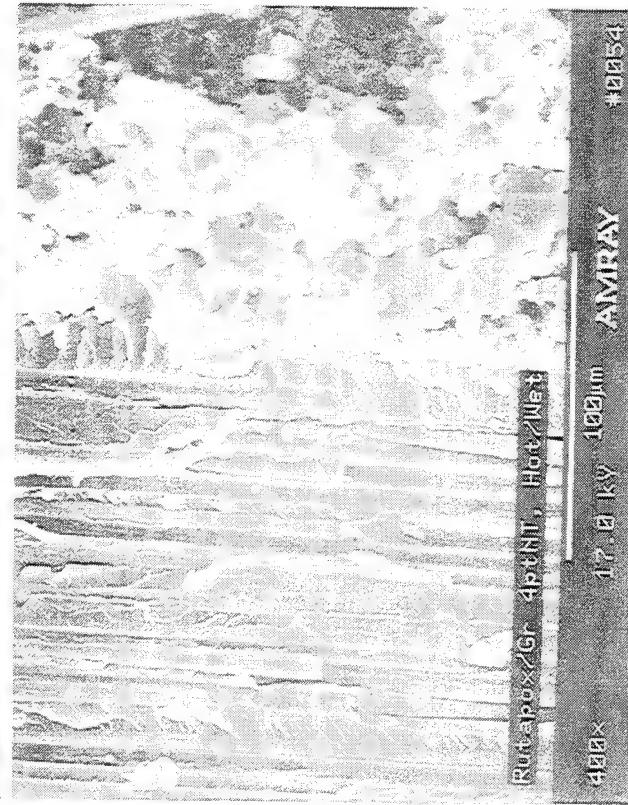
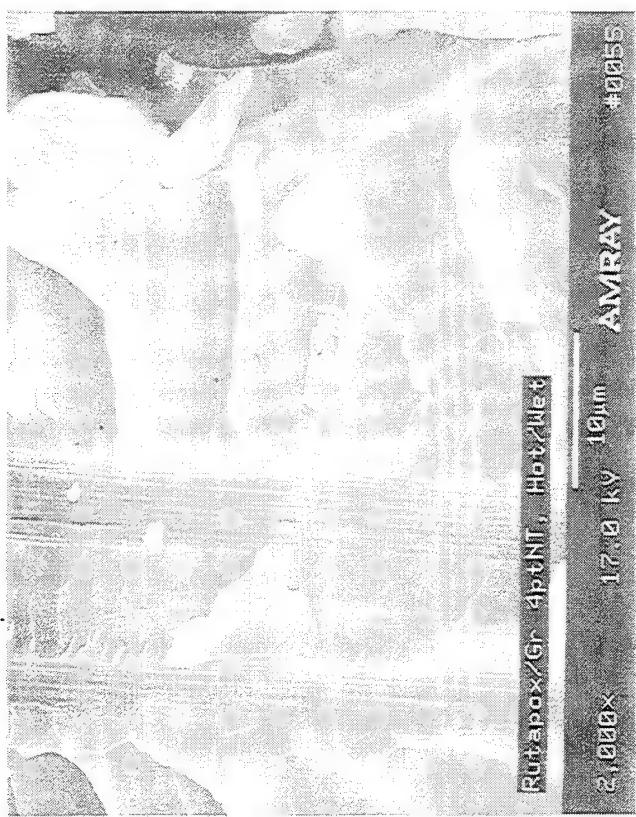
Both fracture surfaces (Figures 3.7-7 & 3.7-8) were similar and both contained slightly oval fibers with longitudinal striations. There was little correlation between the fiber end fractures and the macroscopic fracture direction. In addition, even though there was fairly good wetting of the fibers by the resin, it was difficult to determine the fracture direction on the ply surfaces parallel to the fracture direction. Few fracture morphology features were evident on these surfaces.

Figure 3.7-7. SEM Fractographs of a Rutapox/Graphite Roving 4ptNT Fracture Surface, Hot/Wet

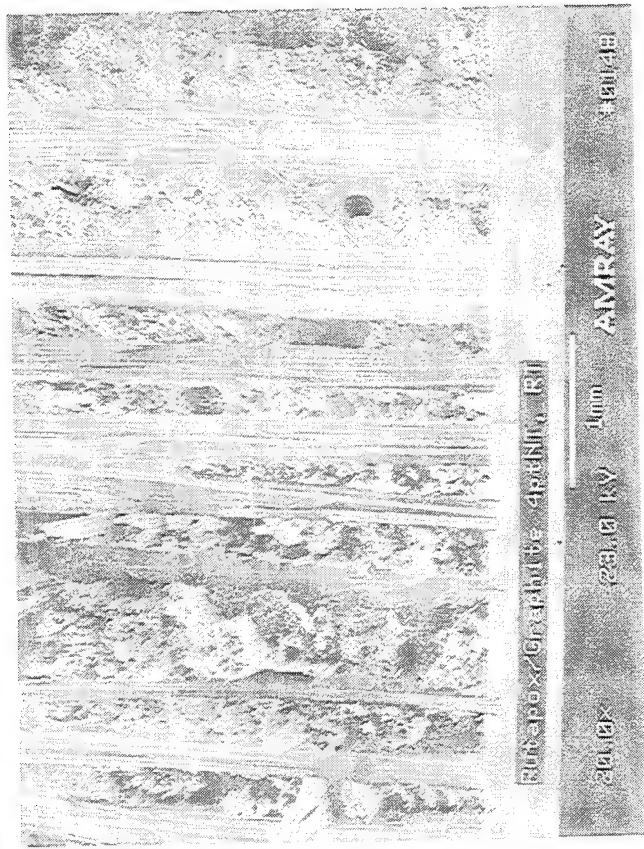
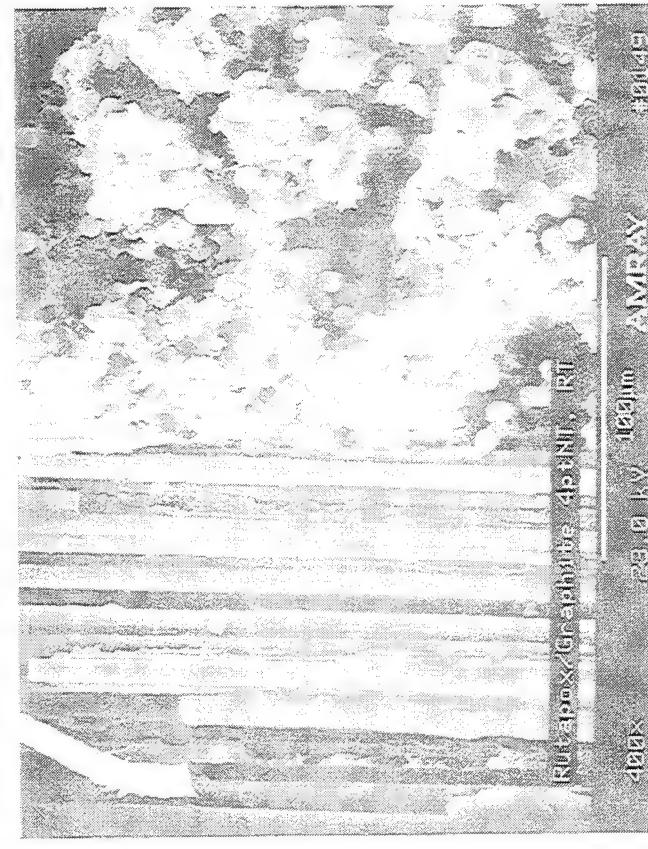
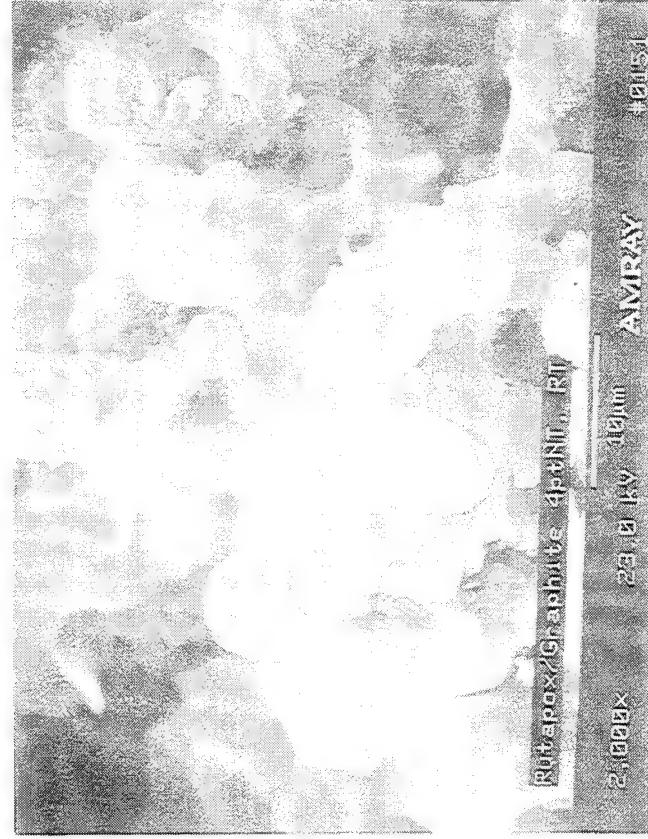
Figure 3.7-8. SEM Fractographs of a Rutapox/Graphite Roving 4p1NT Fracture Surface, RT

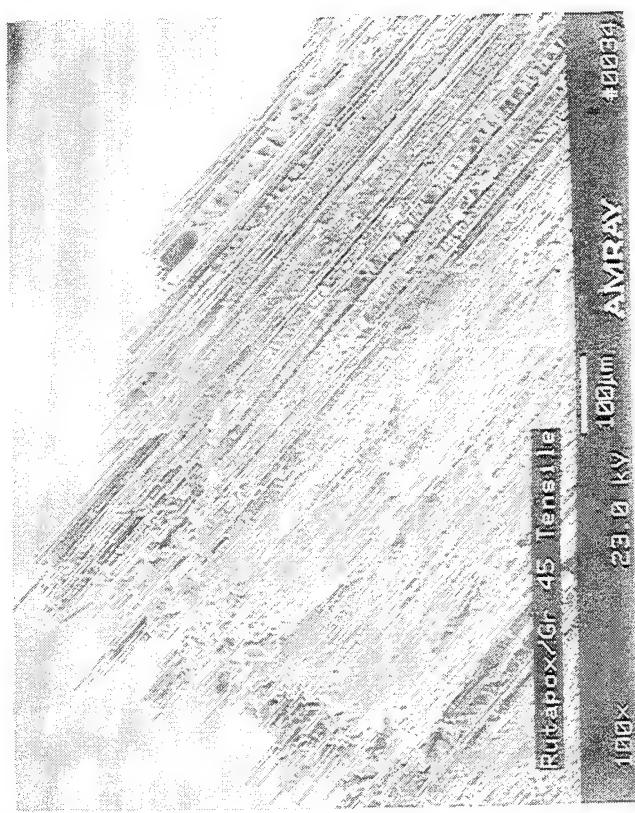
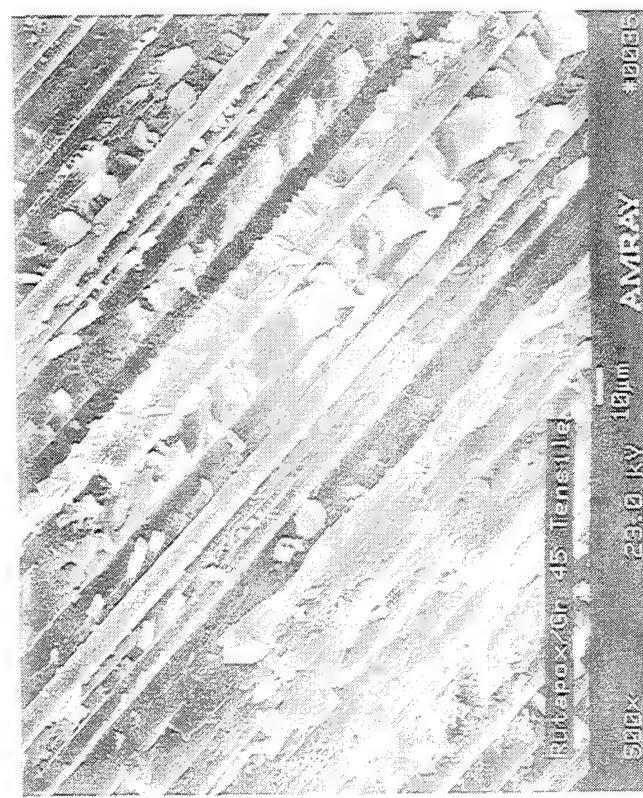
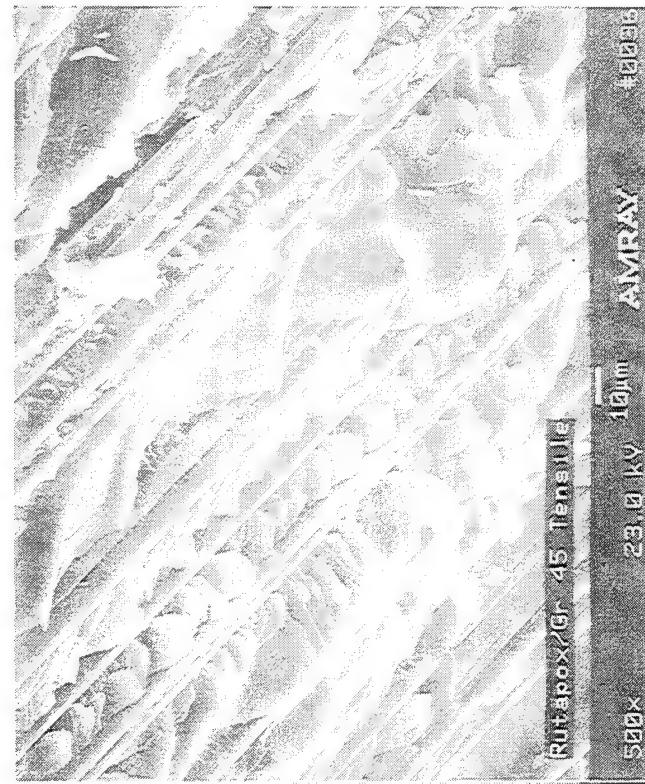
The overall appearance of the fabric surface exhibited both mode I and II fracture features (Figure 3.7-9). The orientation of the hackles did not give an obvious indication of the overall crack propagation direction.

Figure 3.7-9. SEM Fractographs of a Rutapox/Graphite Fabric $\pm 45^\circ$ Tensile Fracture Surface, RT

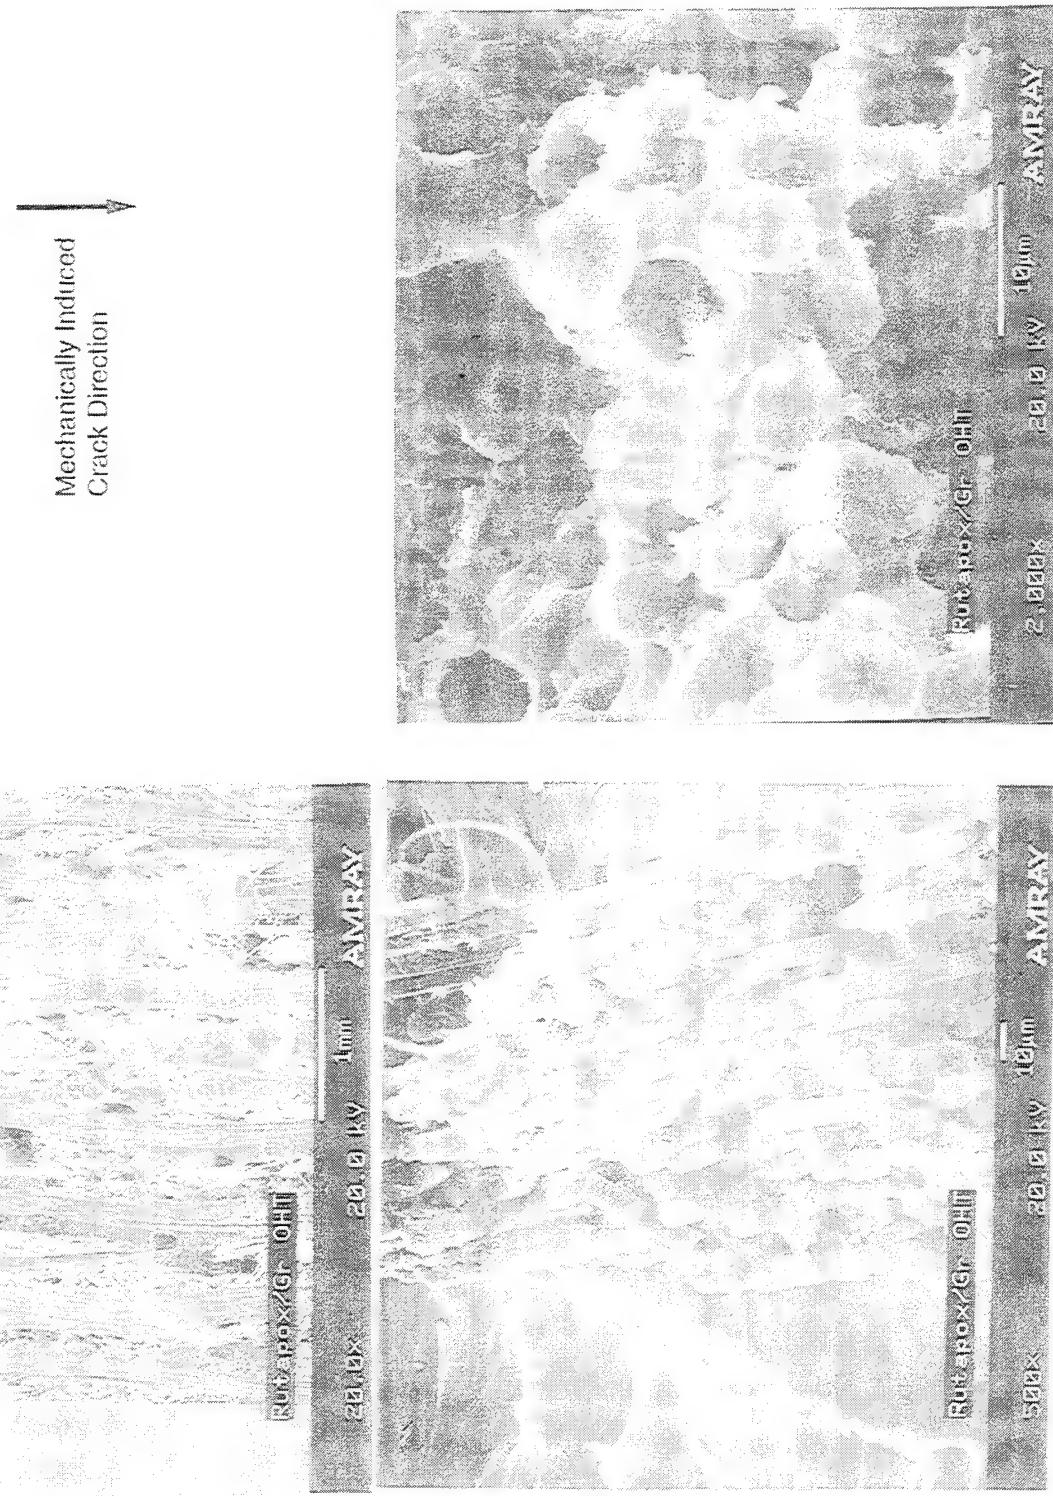
The fiber ends did not clearly indicate the overall crack direction from examination of a small sample (Figure 3.7-10). The fibers were oval and contained distinct longitudinal ridges. Tracer yarns in the fabric were clearly visible and were initially confused with some type of fiber pull-out condition. The plies parallel to the crack direction had hackles on the surfaces, but it generally appeared that these tow regions were pulled apart in a mode I.

Figure 3.7-10. SEM Fractographs of a Rutapox/Graphite Open Hole Tension Fracture Surface, RT

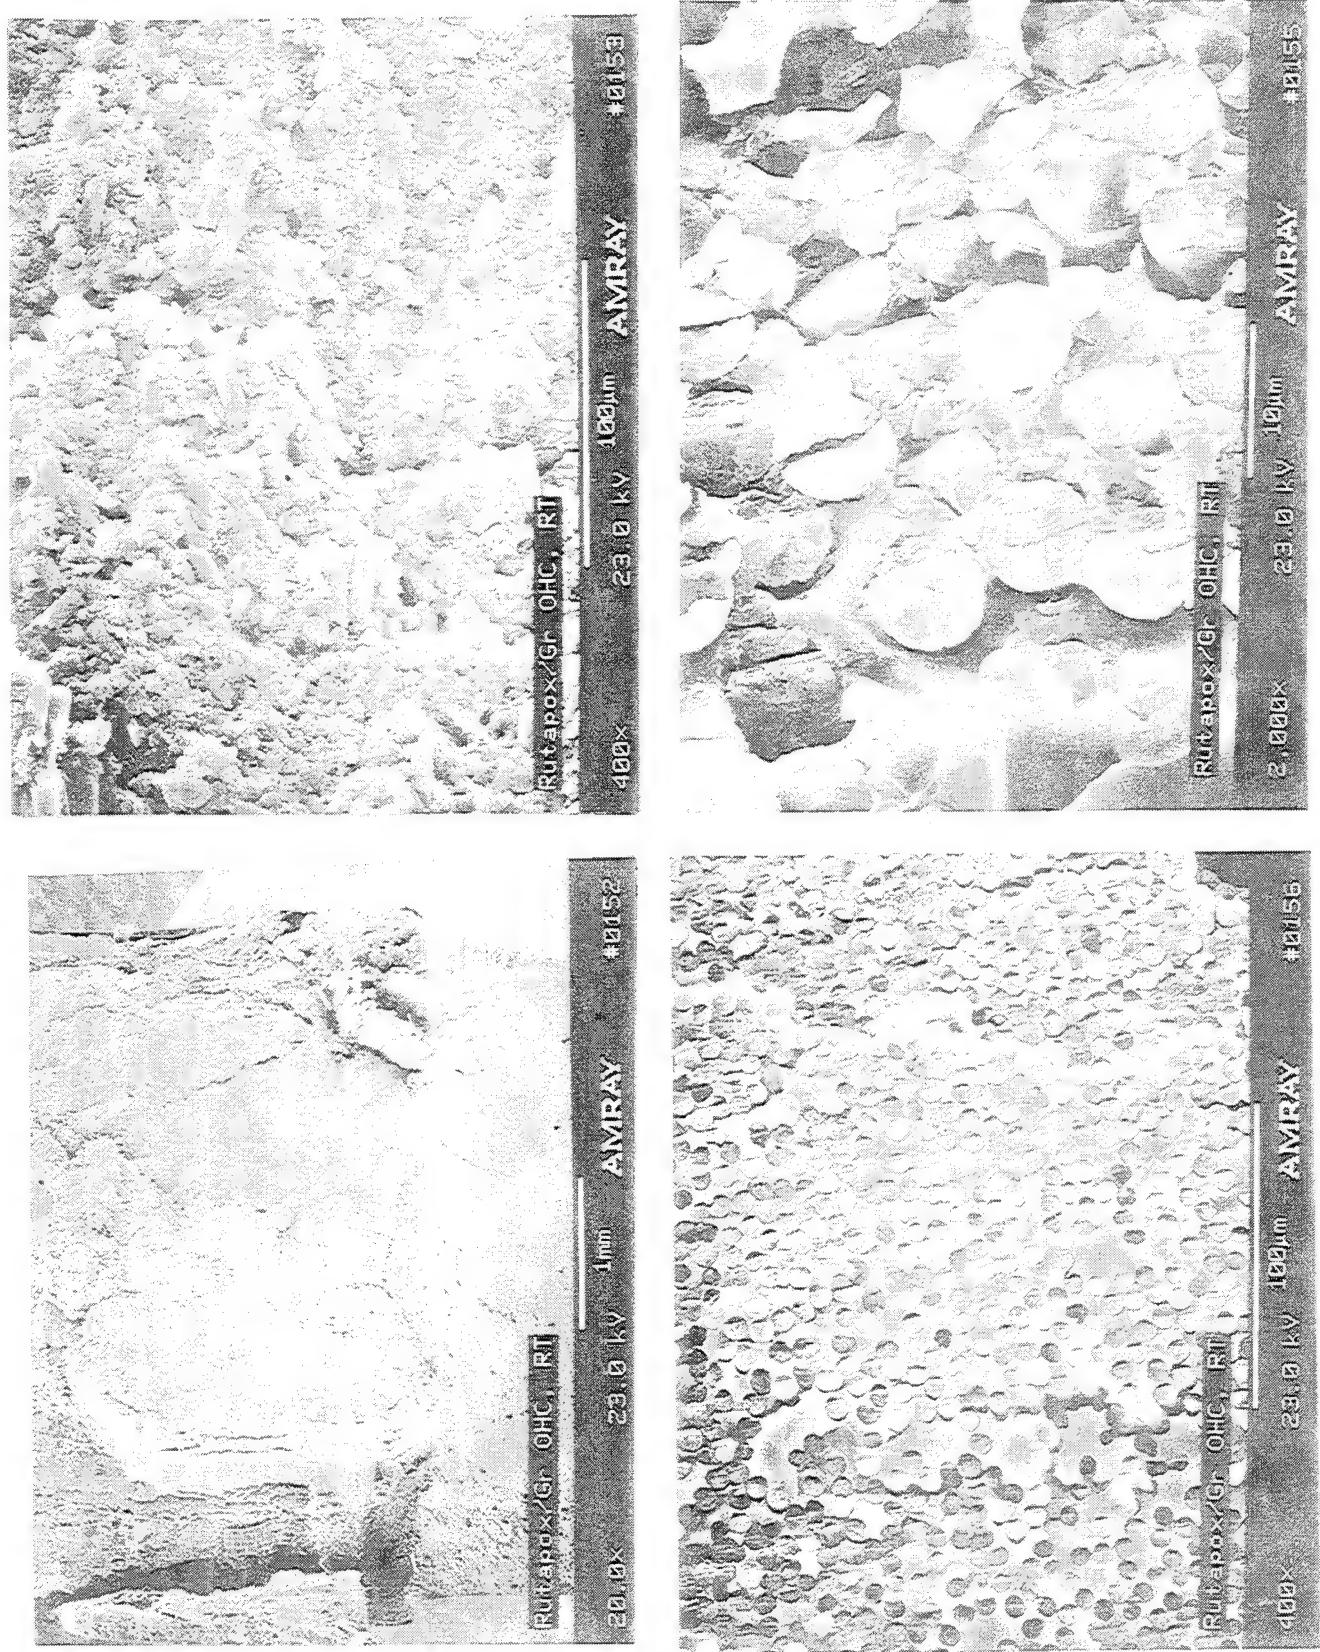
Two distinct regions were present on the fracture surfaces (Figure 3.7-11). The region adjacent to the hole contained a great deal of rubble covered with small sections of fractured fibers. The regions further away from the hole exhibited the classic compression fracture morphology with the distinct centerline through the fibers. In addition, some of the fibers were actually split along their centerline to an unknown depth.

Figure 3.7-11. SEM Fractographs of a Rutapox/Graphite Rovings Open Hole Compression Fracture Surface, RT

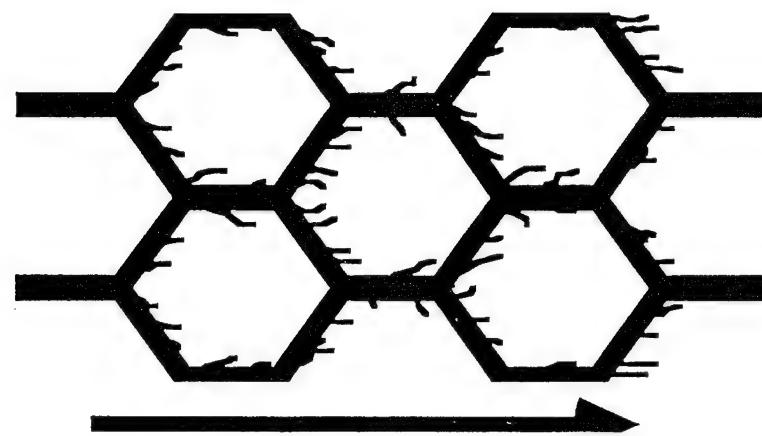
Figure 3.8-1. Fibers Torn and Bent in the Direction of the Propagation of the Failure

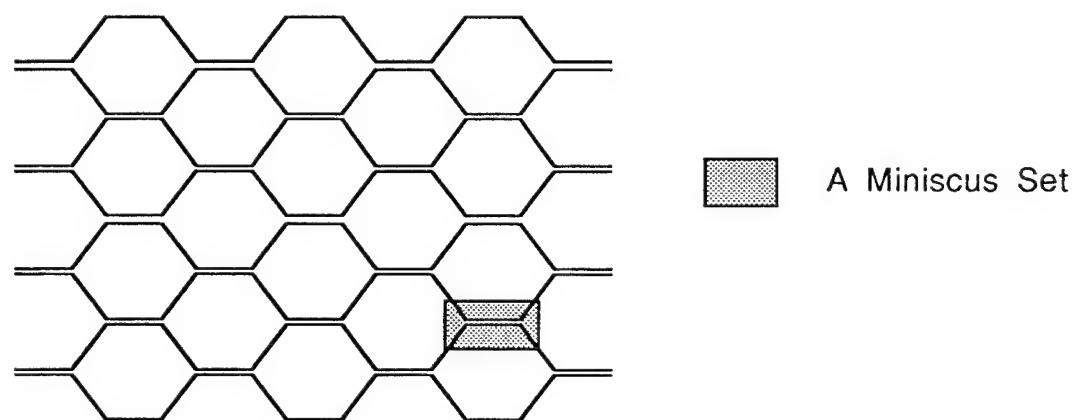
The locations where the ribbons join have a double ribbon thickness and additional resin to strengthen that location (see Figure 3.8-2). The resin meniscus is a trilobate structure, with its weakest points at the terminations of these lobes or arms, which are directed 120 degrees from one another. In all the test specimens, the loading occurred such that propagation direction for the failure would be parallel to the ribbon direction. The failure could propagate only along one of three paths. Two of these paths were along single plies of ribbon oriented at 60 degrees from the line of the ribbon junctures. The other direction was that of the ribbon juncture (see Figure 3.8-3). Whenever one of these juncture areas failed, both menisci were involved. If the failure was the result of a traveling failure front, then one of the menisci broke from the juncture outward (the trailing meniscus) and one broke from one of the arms along the single-ply edge of the cell (see Figure 3.8-4). This meniscus set thereby indicates the propagation direction for that joint. The propagation direction for any one meniscus set may not be consistent with the overall direction of failure. The failure propagation

Figure 3.8-2. Orientation of the Continuous Ribbons in the Honeycomb Denoting the Ribbon Direction and the Associated Meniscus Set

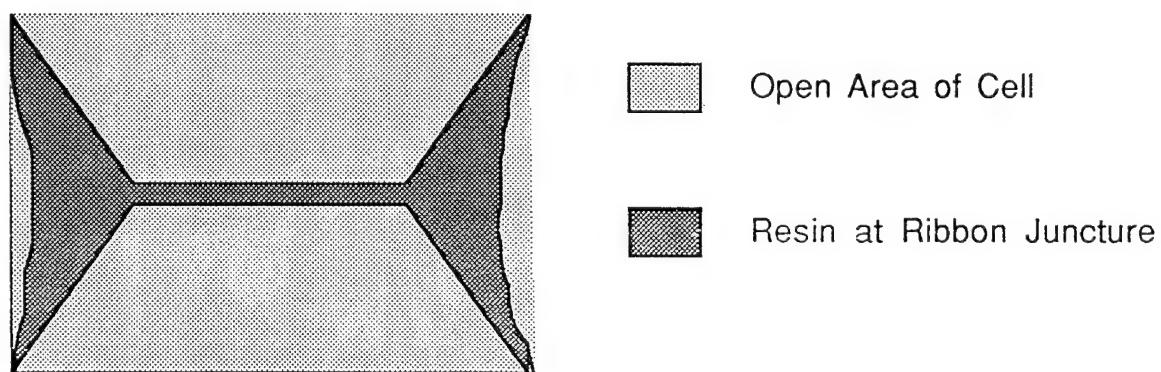
Figure 3.8-3. Trilobate Resin Structure at the Ribbon Juncture Forming a Pair of Menisci or a Meniscus Set

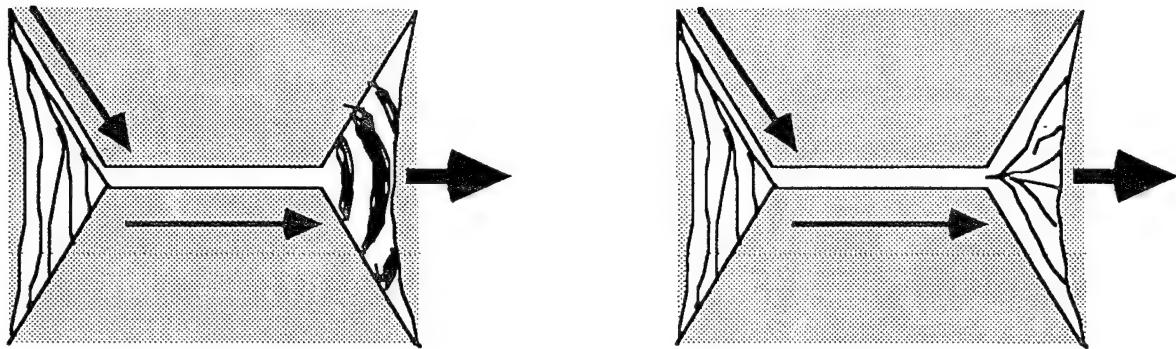
Figure 3.8-4. Failure Patterns in the Resin Menisci Indicating the Propagation Directions

The illustration on the left shows "Wallner" lines indicating the failure initiated at the apex of the upper arm of the meniscus. It then propagated across the joint and caused a conchoidal fracture in the trailing meniscus. The illustration on the right shows the same type of event but with a Wallner line failure pattern at the trailing meniscus.

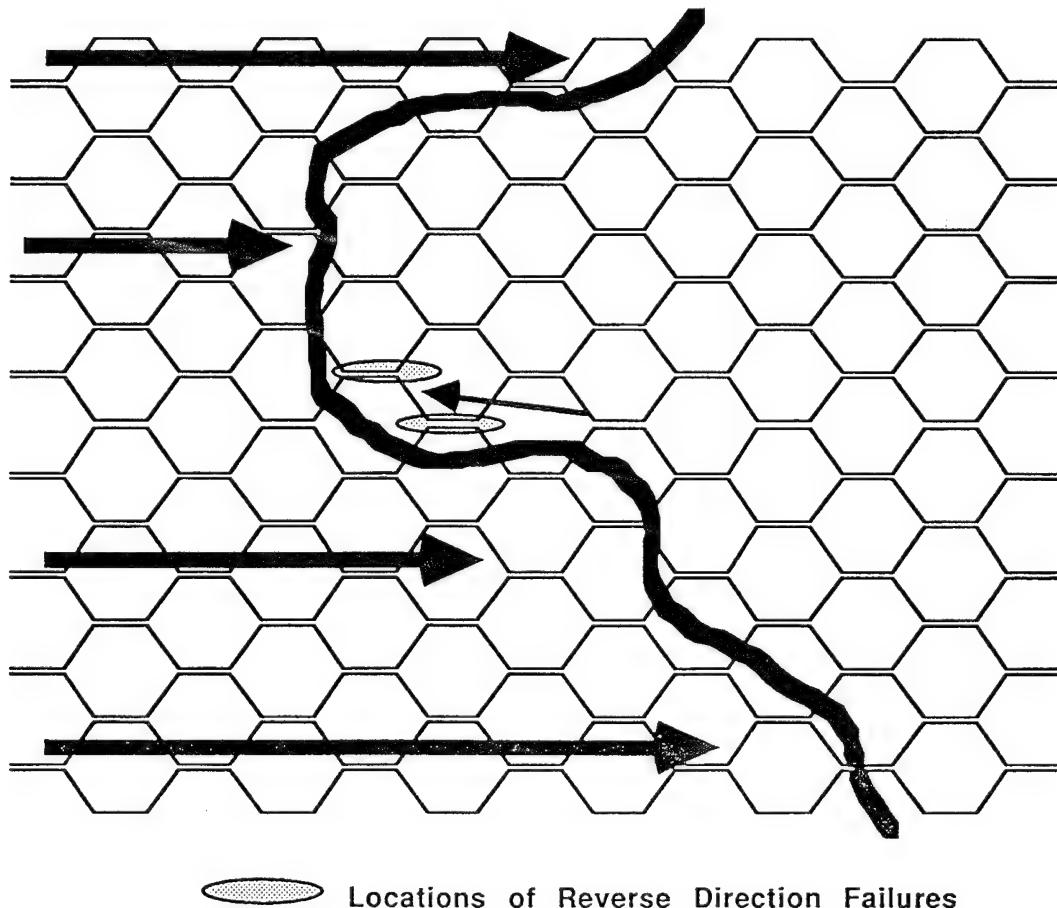
front is not always a straight line (see Figure 3.8-5), which can result in local areas where the failure front may temporarily loop back on itself before jumping back to the main front. This would generate a meniscus pair with a failure propagation direction that was the reverse of the general propagation direction for the panel. Other possibilities include patterns that would indicate a direction of propagation at right angles to the ribbon direction (Figure 3.8-6) or vertical, with both menisci breaking in toward the center (Figure 3.8-7). As a result, the propagation direction on the scale of an individual honeycomb cell based on the meniscus resin failures would not reliably indicate the overall direction of the failure. Multiple sets of menisci would have to be examined to be confident in the overall direction of failure.

Figure 3.8-5. The Failure Front Doesn't Travel as a Straight Line and May, for Short Distances, Change Direction

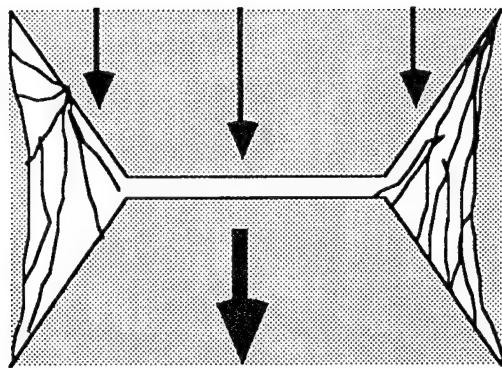
Figure 3.8-6. The Wallner Line Pattern for a Failure Propagating Normal to the Ribbon Direction

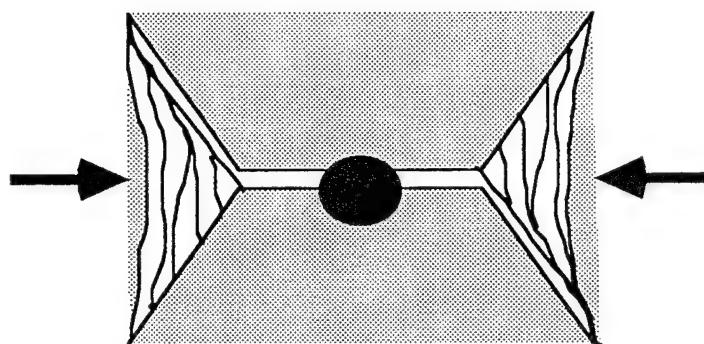
Figure 3.8-7. The Wallner Line Pattern for a Failure Propagating Inward From Both Sides Indicating a Vertical or Twisting Failure

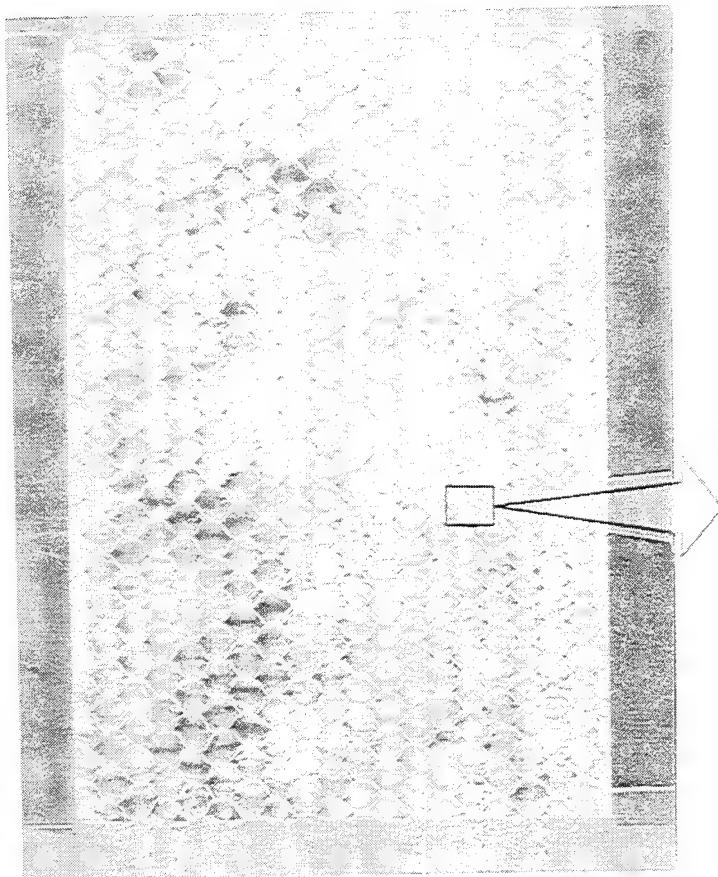
Sample 1A

Control Specimen. No adhesive or cohesive failures were seen in these specimen types. As shown in Figure 3.8-9, 100% core failure was observed.

*Figure 3.8-9. Optical Fractographs of Mode I Sandwich, Control Specimen
Sheet 1 of 2*

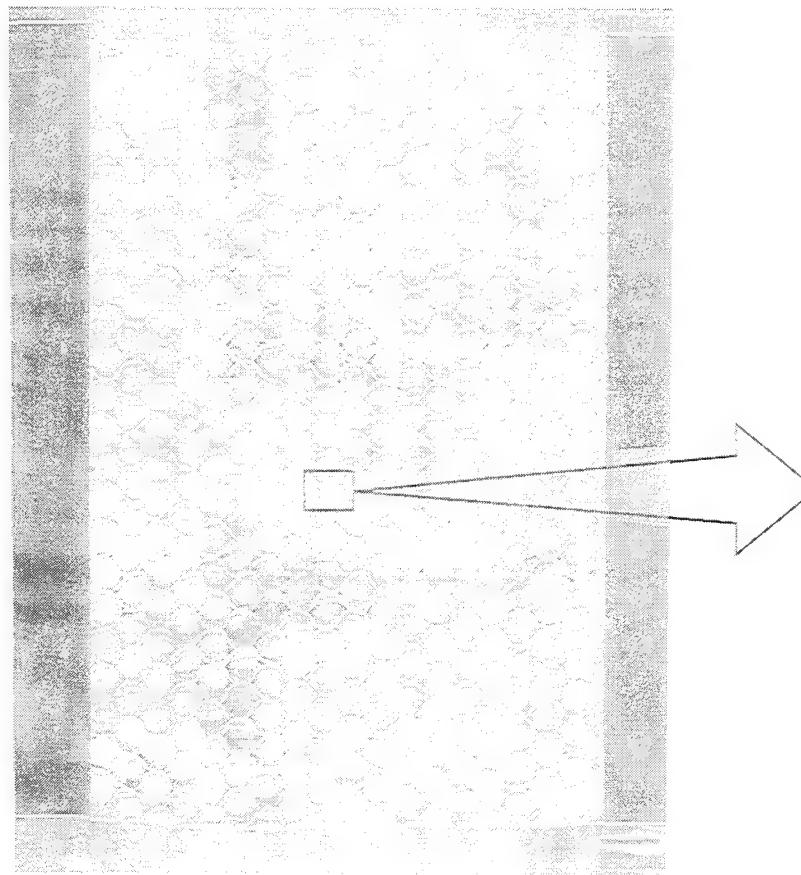
Sample 2B

Aged Adhesive Specimen. The honeycomb cells appeared to be more distorted in these specimens than in the others. It has not been determined if this is the result of processing or testing. The amount of burst fibers was less than that seen in the control specimen. As shown in Figure 3.8-10, the failure was in the honeycomb.

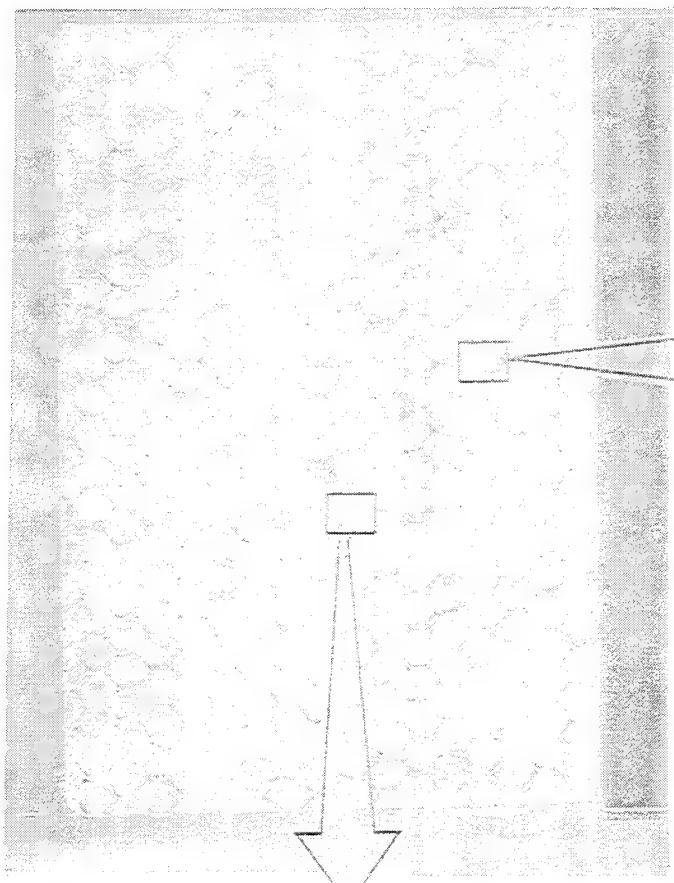
Figure 3.8-11. Optical Fractographs of Mode I Sandwich, Stronger Core Used (8-lb) Specimen
Sheet 1 of 2

Eight-Pound Core Specimen. The failure occurred primarily in the adhesive layer. Both adhesive and cohesive failure was evident. The adhesive failure, between the adhesive and the face sheet, occurred near the center of the specimen. Approximately 25% of the core failure was observed in these specimens. Optical fractographs taken at 200X showed a lower velocity fracture characteristic as evidenced by the mirror and mist fracture features shown in Figure 3.8-11.

Sample 3B see magnification below

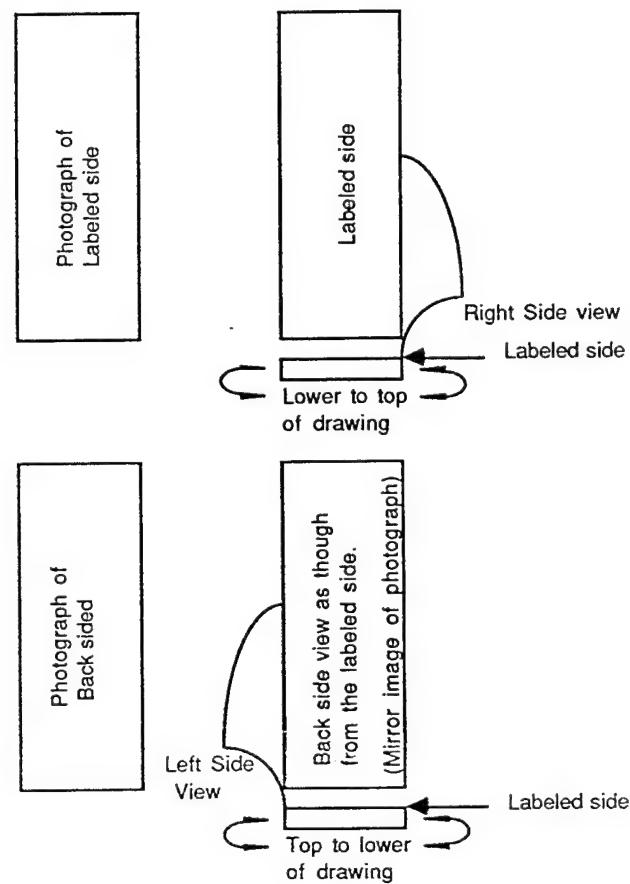
Figure 3.8-14. Illustration of the Position of the Two Photographs and Four Drawings of Each Sample

Samples were photographed as received, and surface failure pattern was documented graphically (see Figure 3.8-14). The pattern of the visible distortion on each of the sides related to the failure is schematically represented. The illustration of the labeled side of the panel is in the same orientation as the photograph of the panel. The edge illustrated just below the labeled side illustration is of the right edge with the labeled side of the panel on the top. The left end of the right-edge view is the lower section of the view, while the right side is higher along the edge. The illustration of the unlabeled side is drawn as though viewed from the labeled side to indicate the relative pattern of the failure on the two sides. The associated photograph is a mirror image of the illustration in this case. The left edge is illustrated below the illustration of the unlabeled side. The left end of the left-edge view is the higher section of the view, while the right side is lower along the edge.

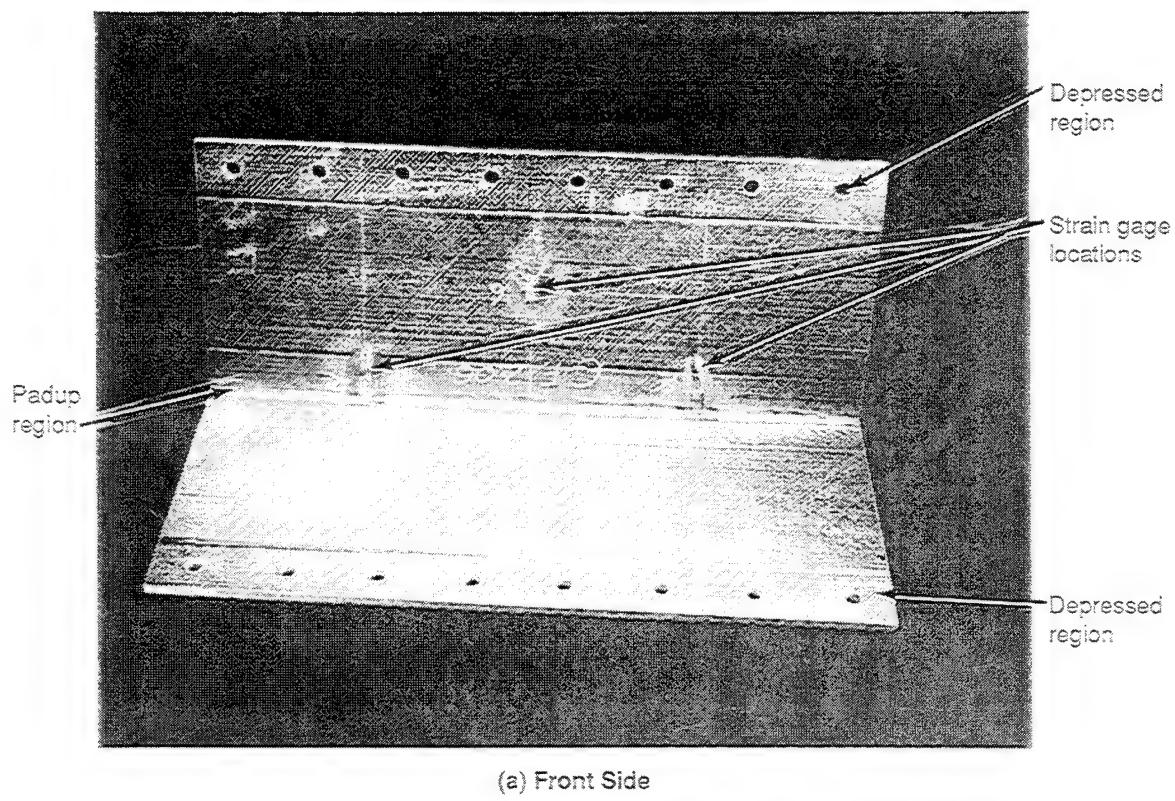
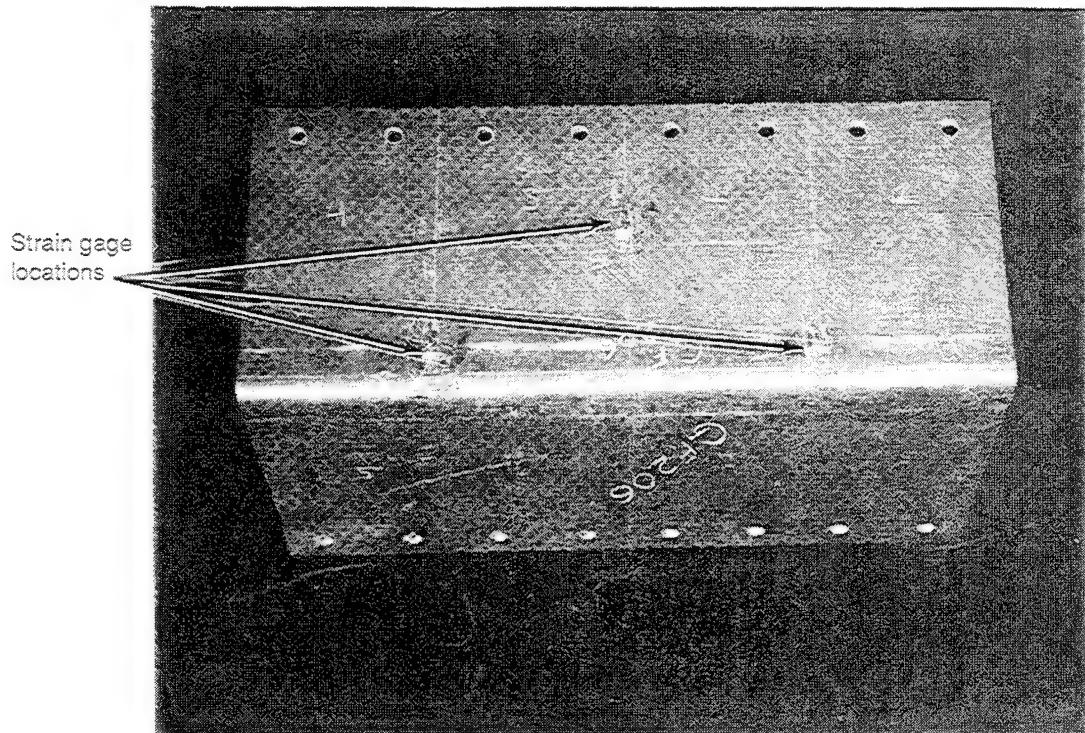
The submitted component (shown in fig. 2) was approximately 14 inches long with 5-inch wide flanges. The thickness was approximately 0.17 to 0.20 inch. The angle between the two flanges was approximately 95 to 100 degrees. The overall color and appearance was indicative of a carbon fiber-reinforced plastic system.

Figure 2. Photographs of the As-Received Component

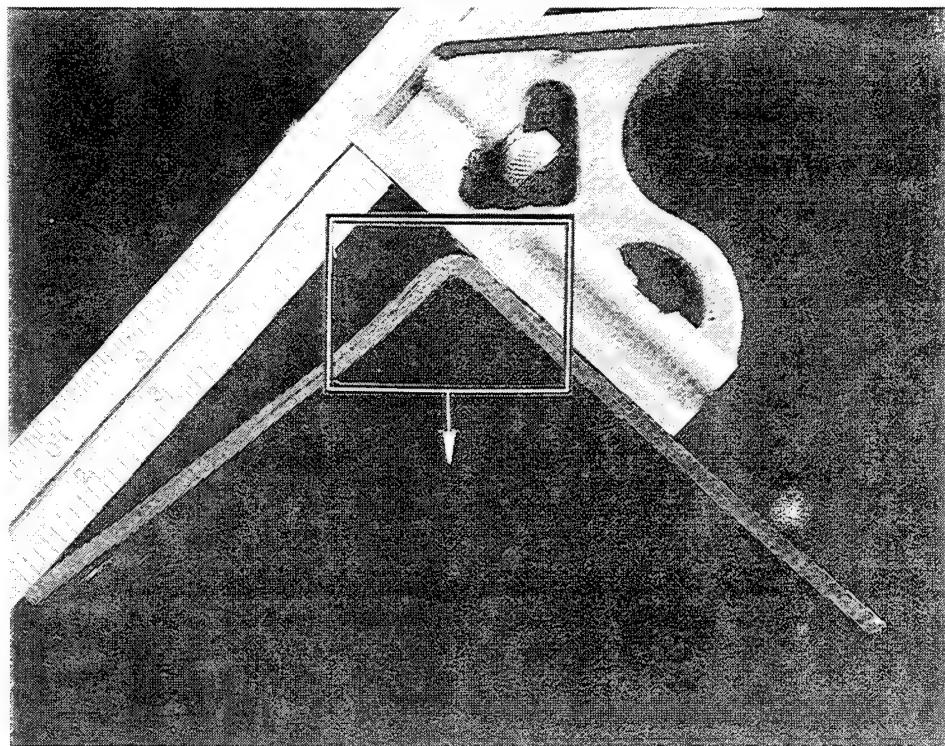
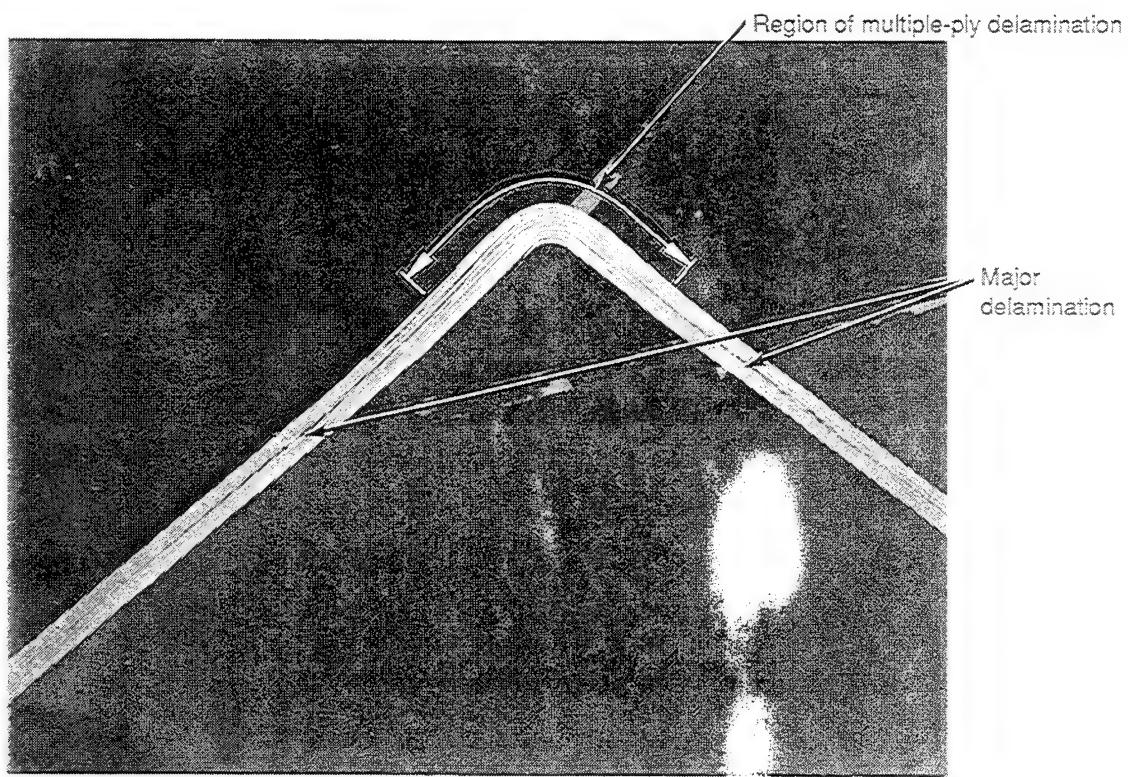
Internal delaminations, observe from both ends of the part, extended from the "knee" or angle region to the edges of the flanges (fig. 3). A 3-inch long delamination was located along the center plies. This delamination extended from an inserted ply placed within the center of the fiber plies at the knee region.

Figure 3. Photographs of the Edge of the Component Showing the Extent of Delamination

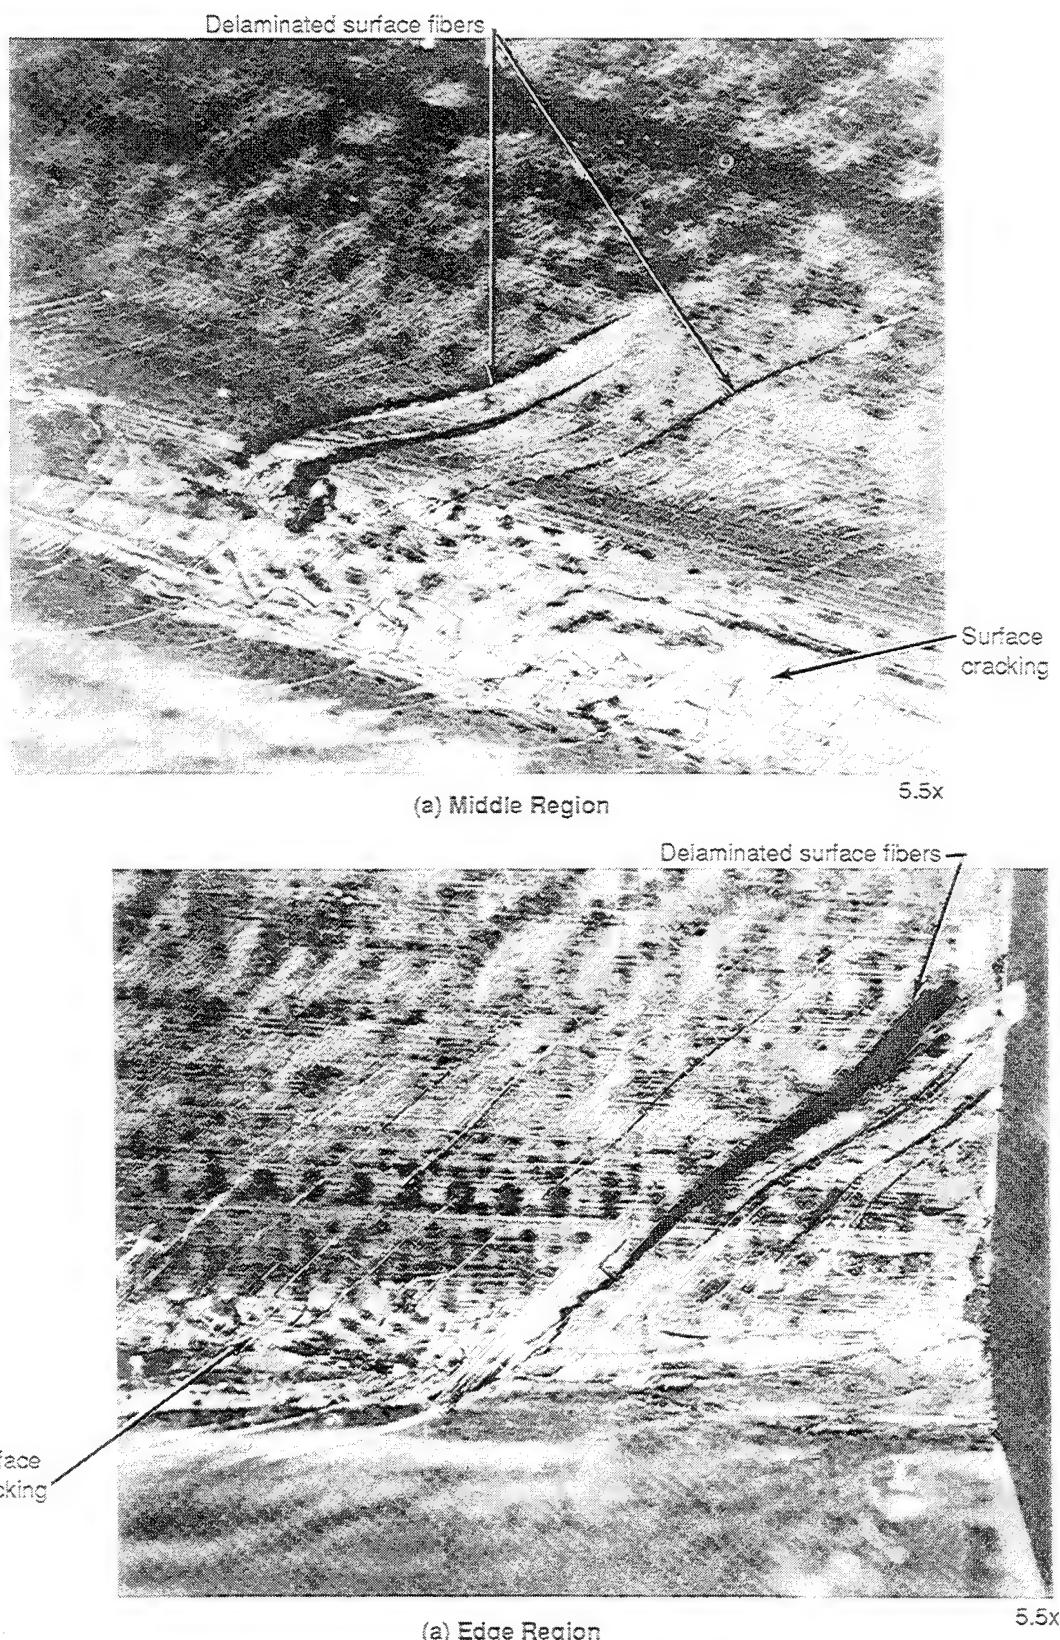
Surface fibers within the inner radius of the "knee" were cracked (fig. 4). Deformations, such as rippling and buckling, were also present along the entire length of the inner radius of the knee. Small indentations and elongated depressions or "tracks" were present along the inner knee surface (fig. 5). The surface of the depressions was shiny indicating that the depressions probably occurred during the fabrication process. Some of the "tracks" contained cracks which went through the surface ply. There were no surface defects or anomalies on the outside surface of the component. Strain gages were located on both sides of one of the flanges.

Figure 4. Micrographs Showing Regions of Surface Fibers Delamination and Cracking Along the Middle and Edges of the Inner Radius

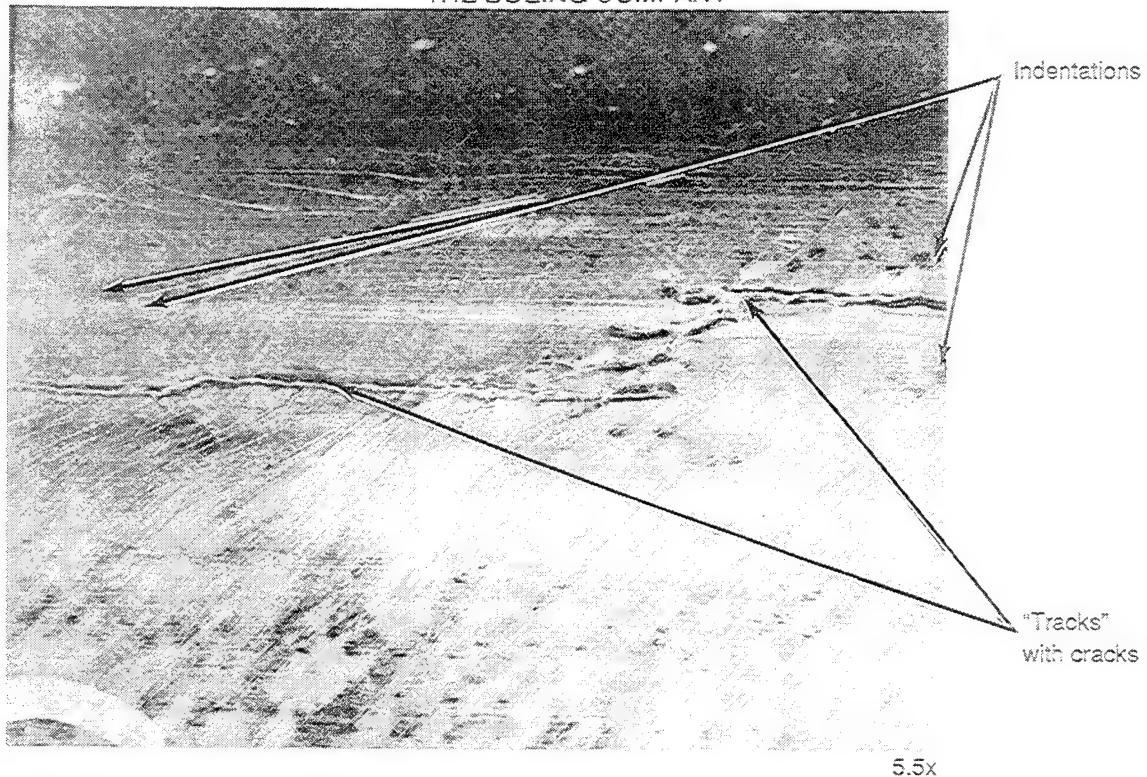
Figure 5. Micrograph of the Indentations and "Tracks" Along the Inner Radius
